DW1000 Errata

Version 1.1

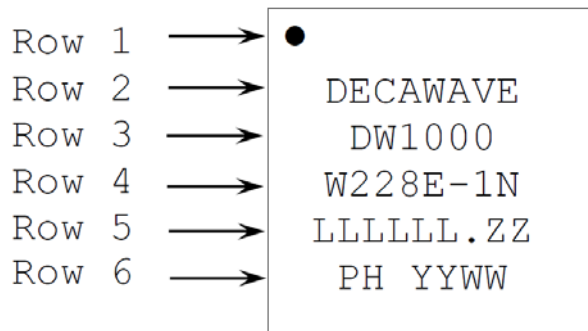
Figure 1 Device Package Markings

* DW1000 silicon revision identifier. In this example the revision of the IC is "E". **Devices marked with silicon revision identifier prior to 'E' (for example 'C') should not be used for DW1000 designs.**
