DW1000 Errata

Version 1.3

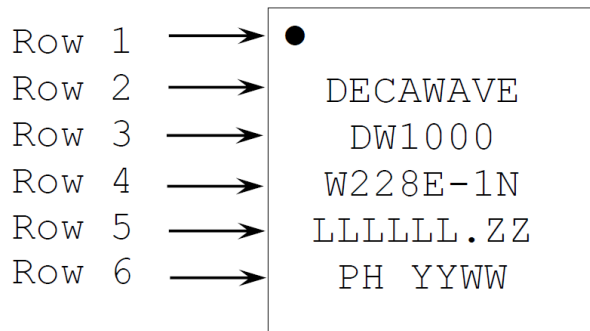
Figure 1 Device Package Markings

Row 1: Pin 1 Designator	Used for device orientation
Row 2: Company Name	DECAWAVE
Row 3: Part name	DW1000
Row 4: DW1000 part number	W228E*-1N

* DW1000 silicon revision identifier. In this example the revision of the IC is "E". **Devices marked with silicon revision identifier prior to 'E' (for example 'C') should not be used for DW1000 designs.**

Row 5: Manufacturer lot number	LLLLLL.ZZ LLLLLL is root wafer fab lot number. ZZ is the lot split number from fab.
Row 6: Package assembly information.	PH : Manufacturing Site Code YYWW : Date Code (YY =Year; WW = Week)
